Manhole Inspection Summary

Manhole # S15CC_007MH

Insp Date: **2/28/08 10:29 AM**

Location Address: **1111 WINCHESTER ST** Cross Street: **WHITMORE AVE**

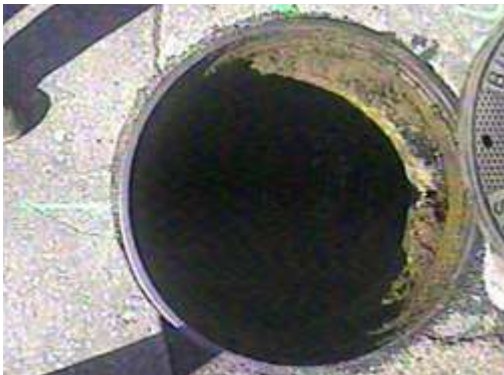
Defect 1

Frame Offset: **4** (in.) Condition: ☒ Sound ☐ Cracked ☐ Leaks

FRAME OFFSET

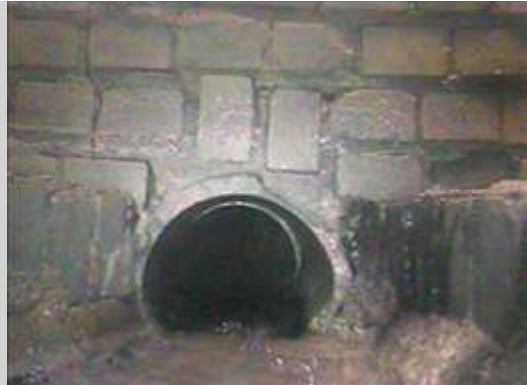
12 O'Clock Outflow

10 in. Circular Gravity Sewer
Pipe Out @ 12 O'Clock

Pipe Height: (in.) Direct
Pipe Material: **Clay** ☐ Pipe Lined
Invert Depth: **11.89** (ft.) Flow Characteristics: **Fast**
Deposits: ☒ None ☐ Mud ☐ Sludge ☐ Debris ☐ Grease
Silt Depth: (in.) Deposits Extent:
Infiltration: **None** Pipe Seal Cond: **Sound**

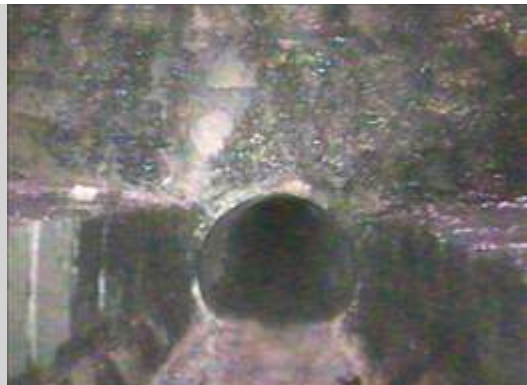
6 O'Clock Inflow

10 in. Circular Gravity Sewer
Pipe In @ 6 O'Clock

Pipe Height: (in.) Direct
Pipe Material: **Clay** ☐ Pipe Lined
Invert Depth: **11.72** (ft.) Flow Characteristics: **Fast**
Deposits: ☒ None ☐ Mud ☐ Sludge ☐ Debris ☐ Grease
Silt Depth: (in.) Deposits Extent:
Infiltration: **None** Pipe Seal Cond: **Sound**

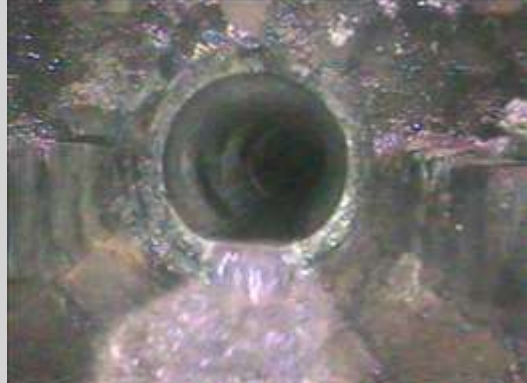
9 O'Clock Inflow

8 in. Circular Gravity Sewer

Pipe In @ 9 O'Clock

Pipe Material: **Clay** ☐ Pipe Lined

Invert Depth: **11.72** (ft.) Flow Characteristics: **Fast**

Infiltration: **None** Pipe Seal Cond: **Sound**
